NATIONAL TRANSPORTATION SAFETY BOARD

Computed Tomography Specialist's Factual Report

CEN17FA127

Location: near Chalmers, IN
Date: March 14, 2017
Time: 1546 eastern daylight time
Airplane: MD Helicopters 369FF helicopter, N530KD

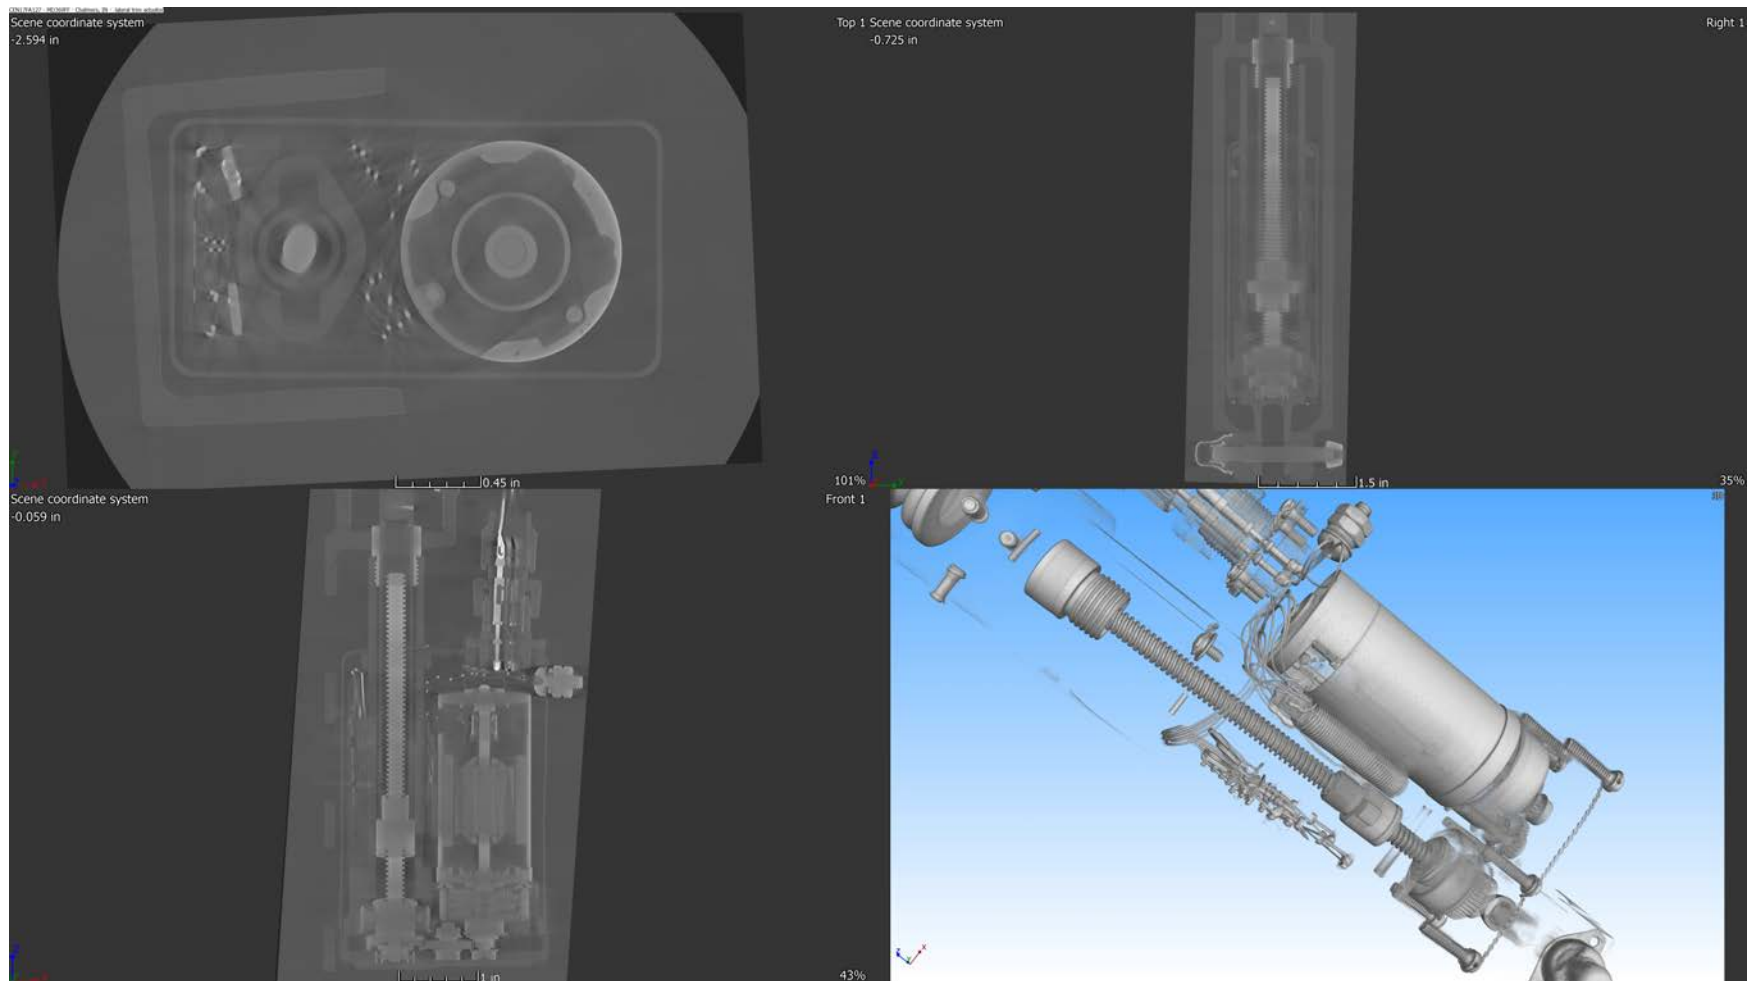
- there was a gap of 0.219 inches noted between the end of the actuator spring cartridge end fixture and the actuator rod end fixture;
- there were 0.517 inches of actuator screw thread between the actuator screw ball and the actuator screw base;
- there were no indications of failure within the actuator motor bearings or output gear train;
- there were no indications of short circuits or other wiring damage within the actuator motor or circuit board wiring;

Figure 47
Lateral trim actuator – gap

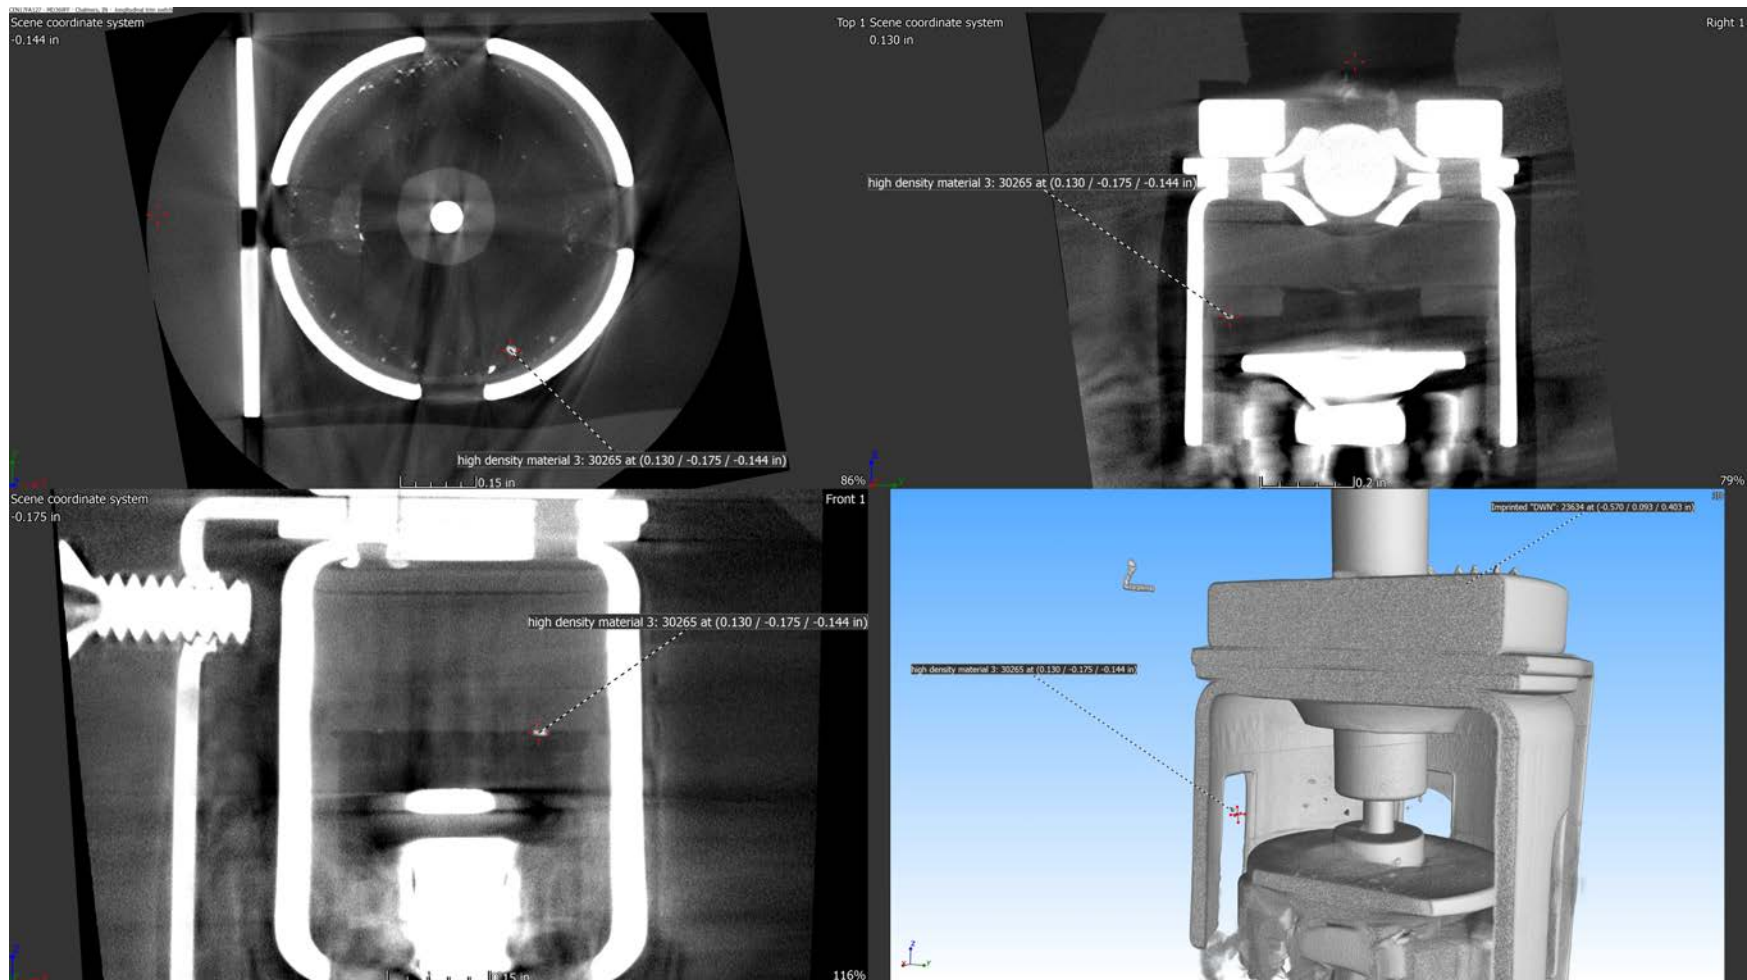
- there were multiple indications of high density particles within the trim switch;
- there were no indications of a material buildup that would have caused a short circuit within the trim switch.

Figure 79
Trim switch – target CT – medium density material
